# INDUSTRIAL CASE STUDY

## PETROL ISLAND REFURBISHMENT

**PROJECT OVERVIEW:** Refurbishment And Longevity Of Petrol Pump Islands

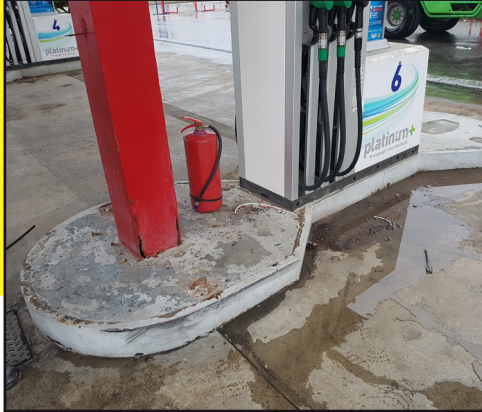
Petrol station pump islands made of steel bezel and concrete often fail due to continuous use. Diesel and gasoline spills rust and corrode the metal bezel, and car tires wear down the concrete islands over time. As a result, the company had to fix and paint the islands every six to twelve months. That was a problem for the company, because even between re-coating, the islands were looking worst for wear.

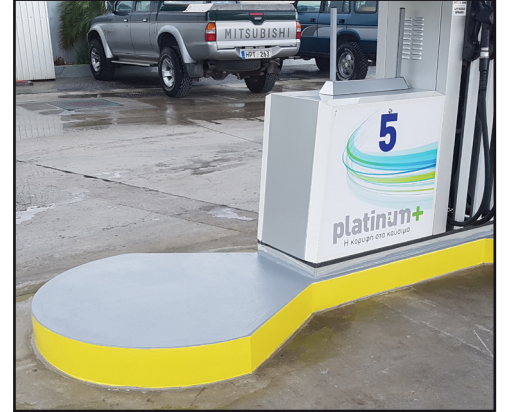
Due to XS-350's chemical and abrasion resistance, the client removed the need for regular maintenance. Their petrol pump stations are now good as new. The durable and tough LINE-X will set them worry free from cars tyres hitting the islands and from fuel spills.
