INDUSTRIAL CASE STUDY

SEAMLESS FLAT ROOFING MEMBRANE

PROJECT OVERVIEW: Waterproof Roofing Membrane

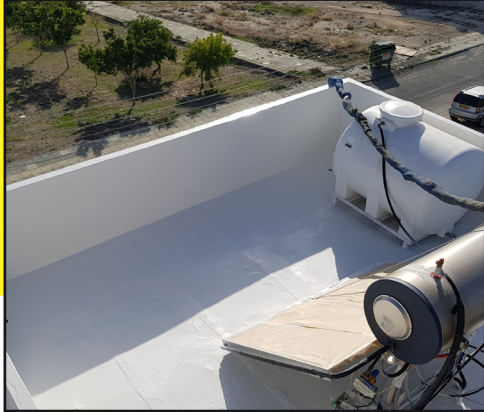
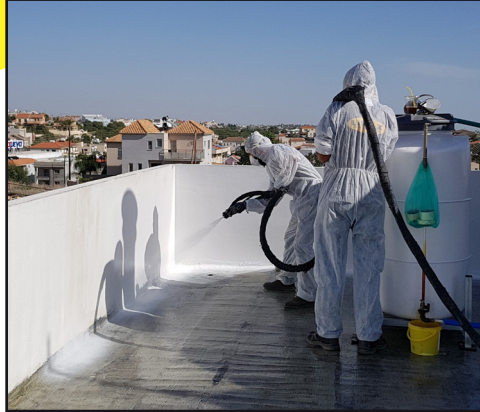
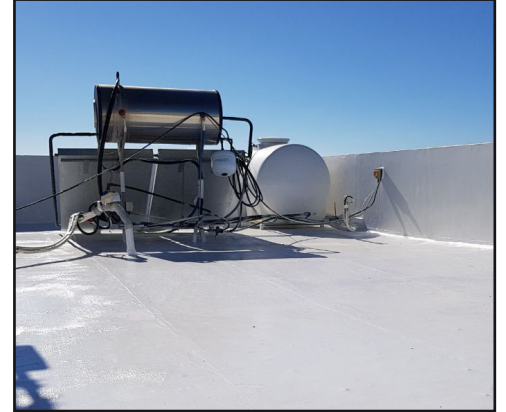
The roof was previously covered with bitumen, a type of asphalt commonly used for flat roofs. Bitumen can breakdown prematurely in fluctuating climate and weather conditions. In the heat of the summer months, the bitumen had cracked along the joints allowing the rainwater to seep through the existing membrane. Moreover, bitumen tends to absorb rather than reflect heat which can superheat the building below.

The previous bitumen was removed, and the area was completely cleaned and prepared prior to priming with Master-top P617 and quartz sand.†

White XS-101 was then applied to completely seal the roof. A white top-coat was applied after the XS-101 to ensure UV stability.†
