# INDUSTRIAL CASE STUDY

## ARROW BOARDS

**PROJECT OVERVIEW:** Automotive — Corrosion resistant lining for arrow boards.

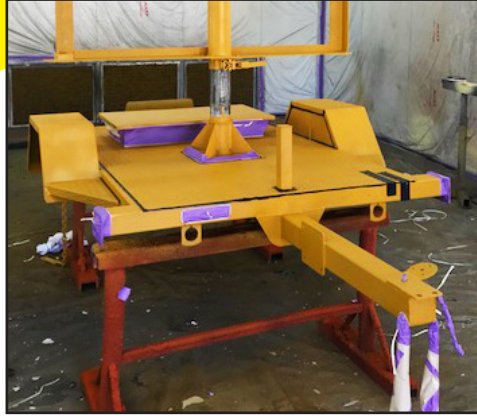
The trailers used to transport and place the arrow boards experience high degree of corrosion, due in part to the harsh Australian weather conditions. This corrosion was reducing the trailers' lifespan — thus increasing maintenance costs for the hire company.

The team at LINE-X completely dismantle the trailer and remove the arrow board. The trailer is then sandblasted before priming with FCP. In this case the client required the equipment remain highly visible, so a combination of Red and Yellow tinted LINE-X XS-350 was applied to the entire surface of the trailer. Finally, all running gear is primed and painted to spec before reassembly.

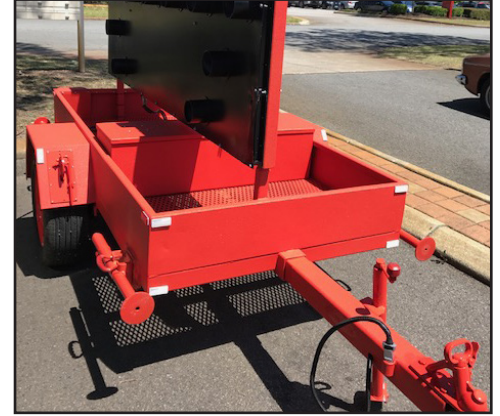
When applied over a properly prepared substrate, LINE-X will eliminate corrosion from the equation, with incredible resistance to abrasion, chemicals, and impact as a bonus.
