INDUSTRIAL CASE STUDY

MEDICAL CLINIC TRIM PROTECTION

PROJECT OVERVIEW: Durable coating for metal door trims and jambs

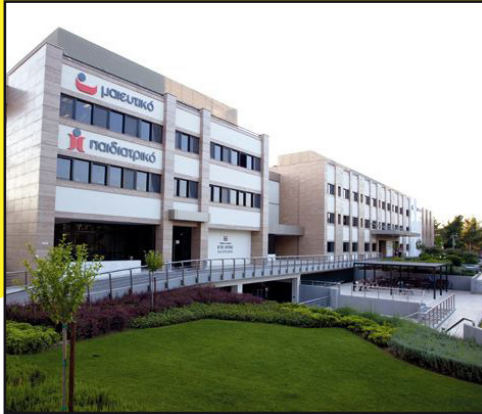
The client, one of the largest private medical clinics in Northern Greece, was experiencing serious problems with the door and wall trim in their clinic. The door jambs and wall trims were deteriorating quickly, unable to withstand the constant scratching and damage caused by medical trolleys used to transport medicines and medical equipment between wards. The trim was deeply scratched and beginning to rust, leaving the corridors looking run-down and unprofessional. They required near-constant maintenance and they frequently had to close down whole wards to repaint the trim and doors; costing them time and money each time. The client turned to LINE-X so they could have a permanent, durable and aesthetically pleasing solution that wouldn't require constant upkeep.

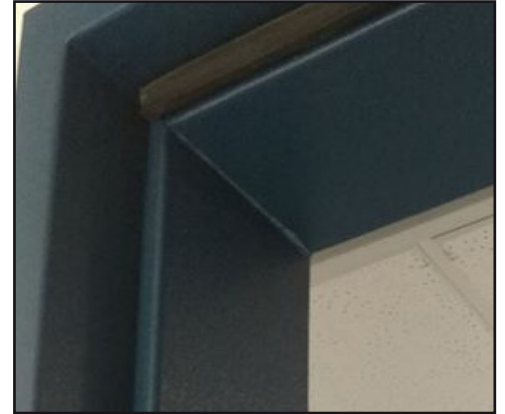
The result is a refreshed-looking ward lined with beautiful dark blue door jambs and matching trim that will withstand the hard-wearing nature of a clinic. The LINE-X coating will not chip or flake by the knocks and scrapes of metal medical trolleys or any other abrasions. The wards will no longer have to be emptied and closed for maintenance; the staff at the clinic were extremely pleased with the result, both in how the ward looked and that they will no longer have to waste time and money. The client is now investigating what else they could have protected with LINE-X.
