# INDUSTRIAL CASE STUDY

## MINING AND PROCESSING TANK LINING

**PROJECT OVERVIEW:** Internal Tank Lining For Abrasion Resistance and Increased Durability

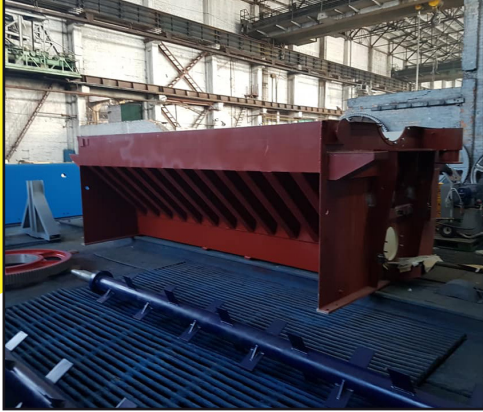
Businesses within the mining and processing industry require huge tanks to store shredded iron ore, but the interior coating of the manufacturer-supplied tanks wasn't able to withstand the abrasion. The tanks would quickly show signs of corrosion and degradation, greatly shortening their service life. The client needed a solution to prolong the life of the tanks that could endure the continual movement of the iron ore scrap.

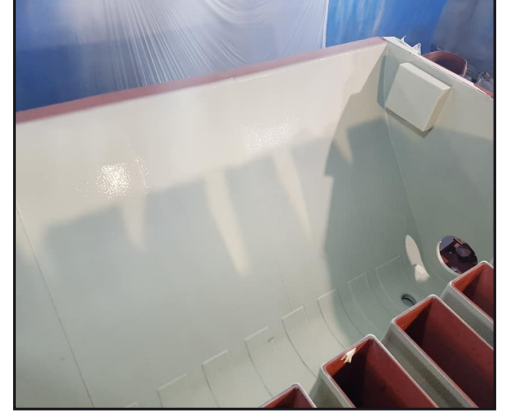
The LINE-X XS-350 application provided an incredibly durable barrier that offered an extremely high level of wear-resistance effectively absorbing strikes, scratches, and abrasions from the ore. The first tanks were lined with LINE-X in 2017 and show very minimal wear. An added bonus of the coating became apparent when the client noticed the LINE-X XS-350 greatly reduced the noise level of the iron ore churning in the tanks. The noise reduction was a welcome surprise and huge relief for the staff!
