INDUSTRIAL CASE STUDY

DAIRY FACILITY PRODUCTION

PROJECT OVERVIEW: Food/Dairy Manufacturing

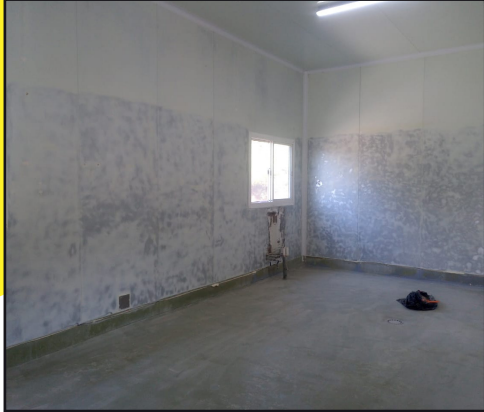
Corrosion is a plague to modern manufacturing; it can strike any industry in any part of the world - even a traditional cheese shop in Cyprus. The walls of this cheese production facility were constructed from steel sandwich panels. Every day, these panels are exposed to salty steam and liquid spills. Most cheese production uses acid and salt at specific stages to make cheese. After so many batches, the steel panels would begin to corrode. The panels often sustained further damage by the collision with and impact damage caused by stainless steel trolleys used to harvest the cheese or progress to the next stage in the process.

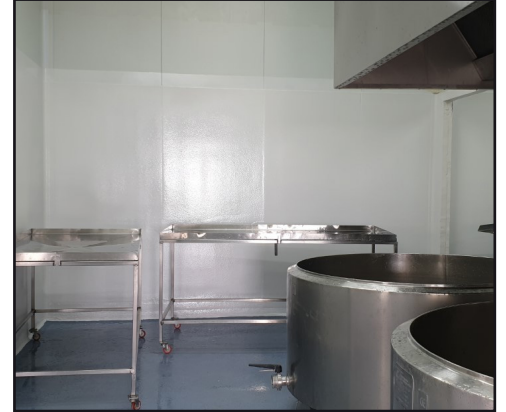
The finished product exceeded the expectations of the manufacturer. Not only was the application completed within the timeline for a fast return to service, but the coating was sprayed in white for a clean appearance. As production resumed, the client was very happy with the immediate results. The panels could take the impact of the trolleys with no damage or abrasion.
