INDUSTRIAL CASE STUDY

OFFSHORE OIL RIG: LAYDOWN AREA

PROJECT OVERVIEW: Damage Resistant Floor Coating

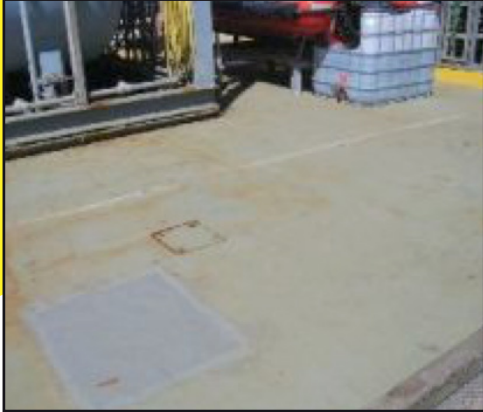
The laydown area on an oil rig was the cause of a major problem concerning its fire protective paint (FPP). The FPP was chipped and heavily damaged by the constant loading and unloading of containers. Fire protection is crucial to the company's operations since the laydown area is above huge gas generators.

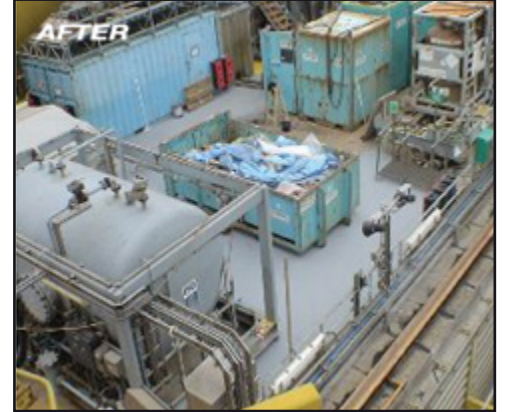
The laydown area was sprayed with LINE-X in the summer of 2005. Without LINE-X, it would have been necessary to re-spray this area at least six times by now. The oil and gas company chose LINE-X for this area not only to get the strongest possible protection, but also to keep re-coating to a minimum and to do it as fast as possible.
