INDUSTRIAL CASE STUDY

COLD ROOM FLOORING

PROJECT OVERVIEW: Concrete Membrane For Cold Room Floor

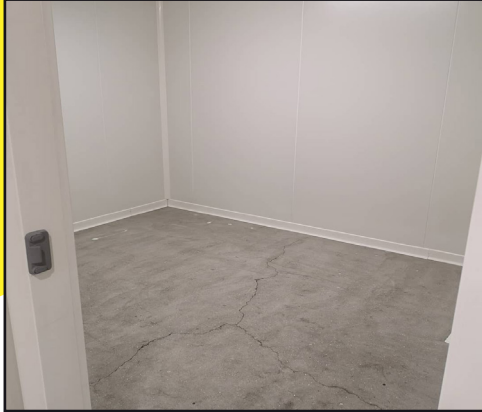
Concrete cold room floors are prone to cracking, which can be extremely problematic. Uneven surfaces can cause health and safety issues, damage to vehicles and racking systems.

This particular cold room in France required a durable flooring system that could tolerate the cold temperatures without cracking, splitting or peeling.

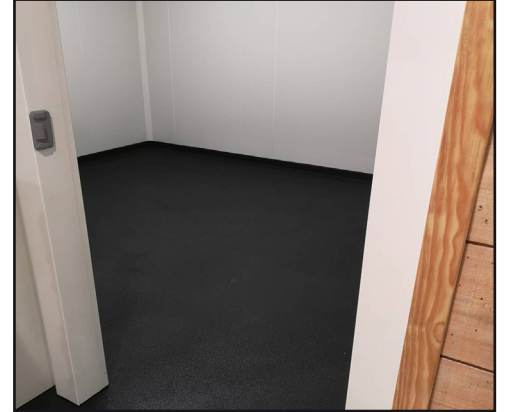
The cold room floor not only looks more professional, but the client can also feel confident that the LINE-X flooring system will stay maintenance-free for many years to come, resulting in less downtime and refurbishment costs. Due to the seamless membrane, there is no place for water or other liquids to ingress, which allows the area to be steam-cleaned or pressure washed without risk of damaging the LINE-X flooring system or the concrete floor underneath.
