INDUSTRIAL CASE STUDY

CONCRETE FOUNTAIN

PROJECT OVERVIEW: Waterproof Membrane for A Concrete Fountain

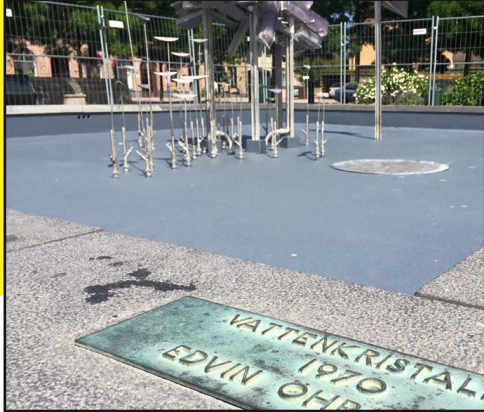
A popular public fountain designed by a Swedish sculptor and glass artist underwent a recent structural refurbishment. The fountain's six-by-seven-meter concrete floor needed a more durable waterproof barrier.

The fountain, built around 1970, has been susceptible to water ingress and weather corrosion. A new waterproofing solution was needed to ensure the work of art continues to stand for years to come.

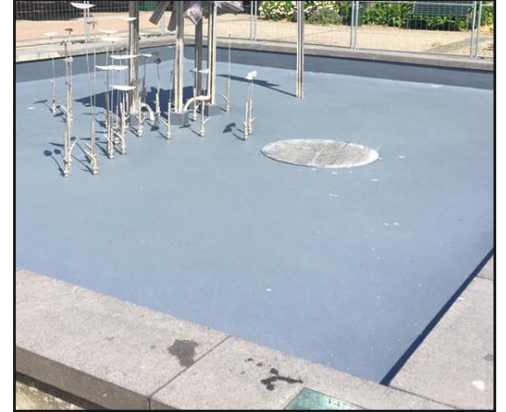
The customer was extremely satisfied with the LINE-X application. The LINE-X application was completed in the spring of 2016 and the waterproof membrane has held up considerably well against seasonal weather and corrosion.
