# INDUSTRIAL CASE STUDY

## FUEL TANK

**PROJECT OVERVIEW:** Construction/Mining/Heavy Equipment'

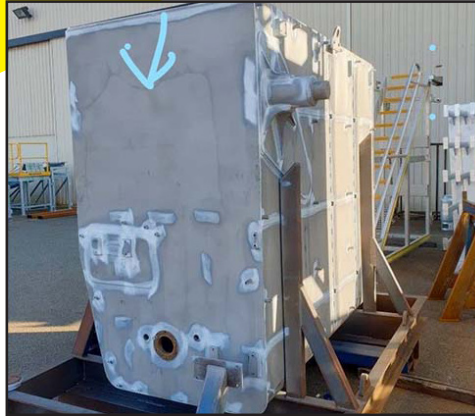
Fuel and hydraulic tanks are particularly vulnerable to deterioration. Because fuel tanks sit between the front and rear wheels, they catch rocks and impact damage from debris that chips away exterior paint and invites corrosion. Regular paint or two-part urethane coatings do not last long in these conditions and require recoating. Even rubber sheets meant to act as an impact barrier eventually fail under the onslaught of debris and moisture.
